# Case Study

## Sealed Road Inspection & Remediation Planning

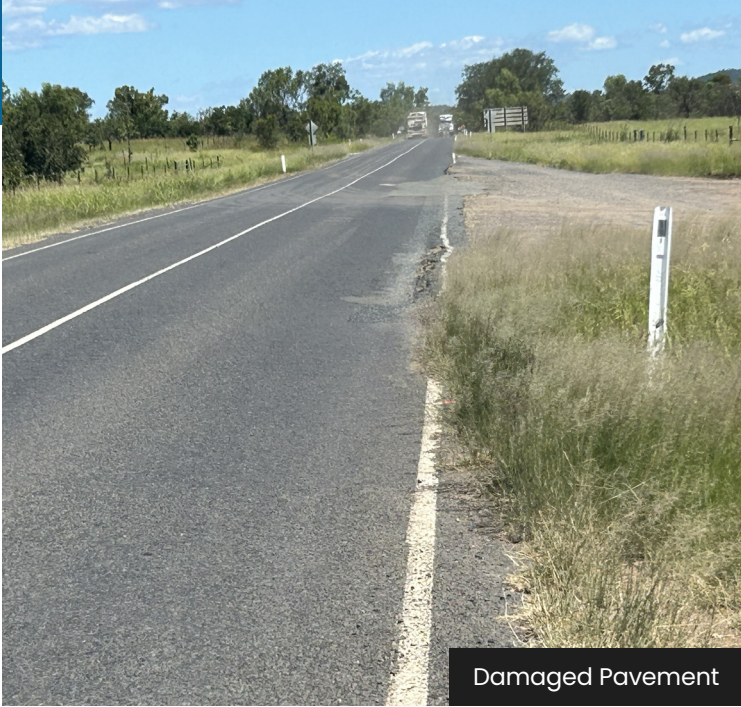
Damaged Pavement

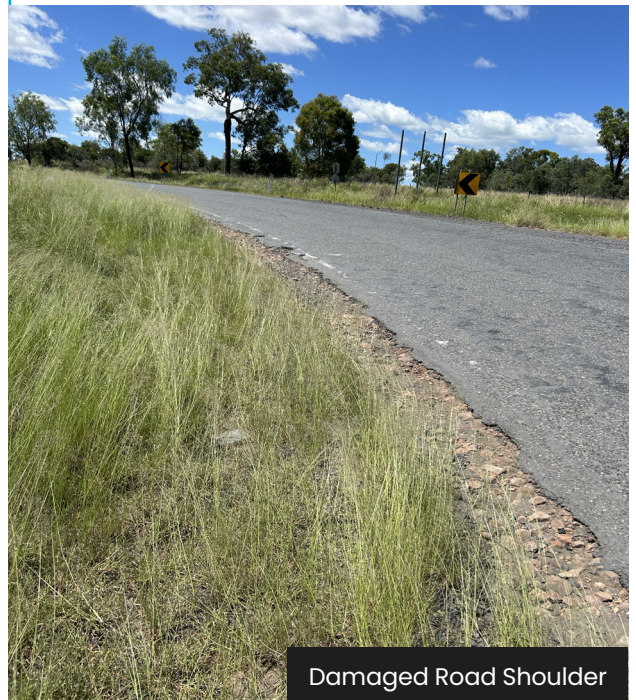
Damaged Road Shoulder

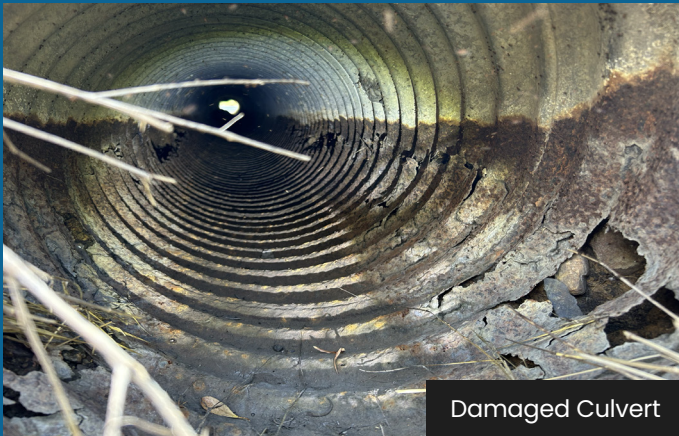
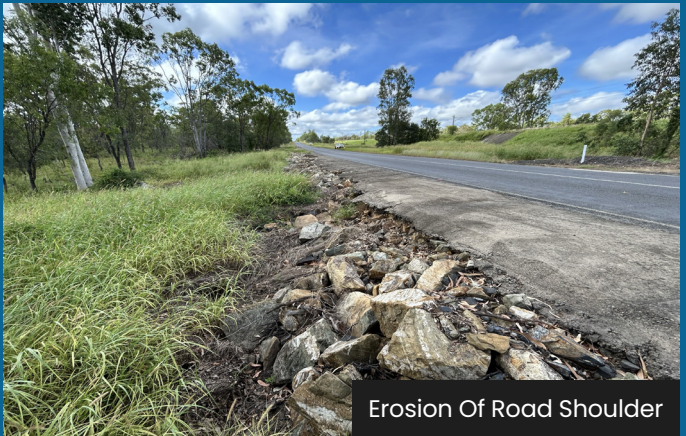
| <b>Fault Number:</b> AR18.1 | <b>Area:</b> Culvert 8400 | <b>Risk Rating:</b> High | 17 |

| <b>Description of Fault:</b> | Culvert holding water and showing signs of corrosion. | |
| <b>Failure Mode:</b> | Failure of CMP. | |
| <b>Potential Incident:</b> | Culvert failure. | |
| | Likely | Will frequently occur. |

| <b>Recommended Action:</b> | Clean inlet and outlet side to improve water flow.<br>Inspect culvert once water is removed. | |
| <b>Action Time Frame:</b> | Prompt Action Required. | |
