# Case Study

## Marion 8050 Dragline Tub Refurbishment

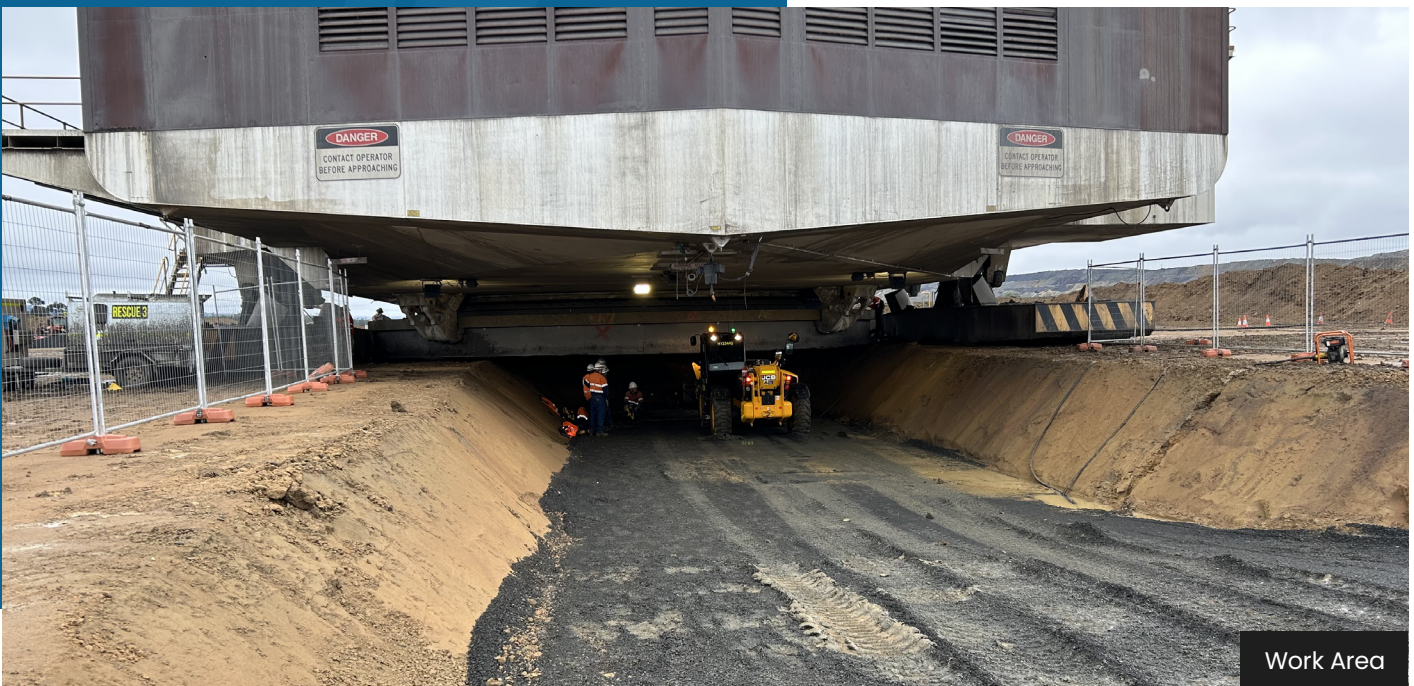
Work Area

While traditional repairs involve **over-plating the existing tub floor**, the extent of damage made this approach unsuitable. Instead, the study determined that **replacing entire sections** of the tub floor would provide a more effective and durable solution.

- **Heavy replacement sections** – The new floor plates weighed **over 5,000 kg each**, requiring careful planning for lifting and installation.
- **Limited headroom** – Precise mounting was essential despite restricted working space.
- **Accurate measurement constraints** – External access was unavailable while the dragline was in service, necessitating **internal laser scanning** for precise plate fabrication.

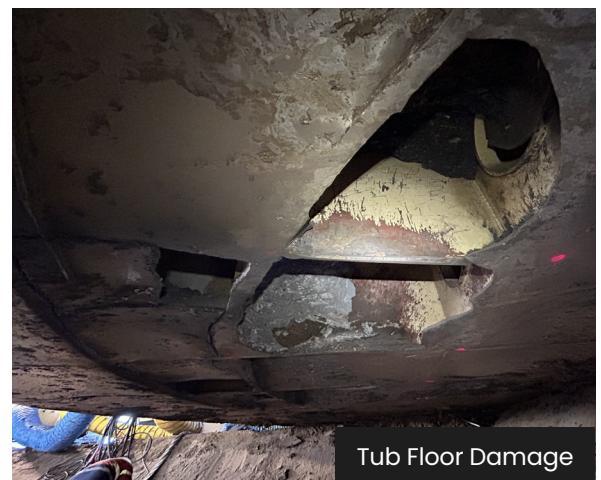
Tub Floor Damage

A Bowen Basin mining company engaged AE Young Engineers to assist with the refurbishment of a **Marion 8050 dragline tub**. After **40 years in service**, the tub had worn through in multiple locations, requiring structural repairs.
