# Case Study

## Material Handling Improvements

## Engineered Solution

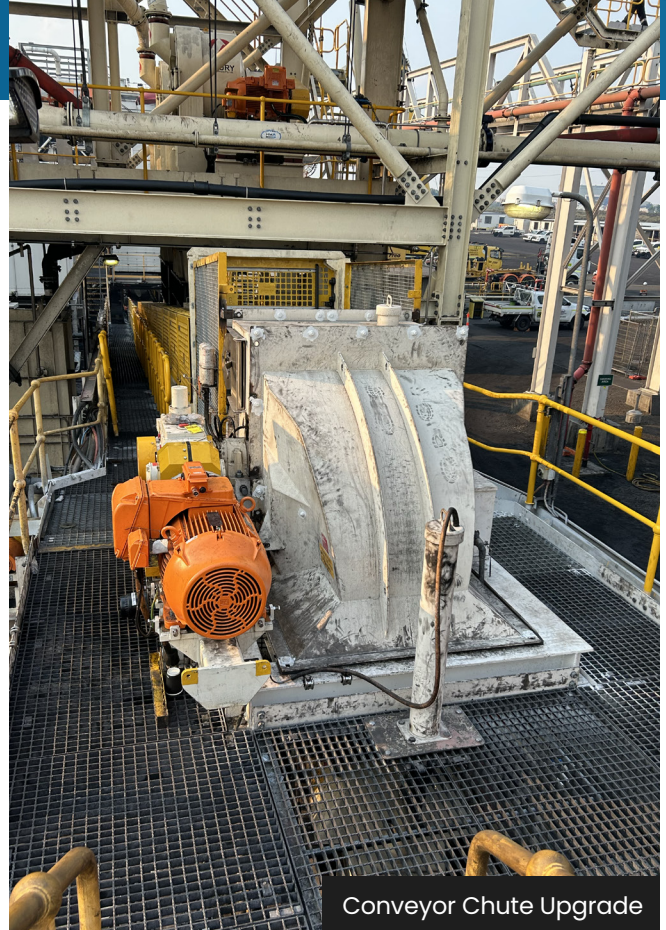
Conveyor Chute Upgrade

AE Young Engineers was engaged to **redesign the conveyor head chute**, addressing carry back while working within **brownfield constraints** (e.g., existing foundations and structural steel).

- ✓ **Replacement head pulley frame**
- ✓ **New dribble chute** with optimized geometry
- ✓ **Modified supporting structure & foundation interface**
- ✓ **Enhanced belt cleaning system**, featuring:
  - Tungsten **primary, secondary, and tertiary belt scrapers**
  - **Snub pulley** for improved belt control
  - **Pressure roller** to enhance scraper efficiency

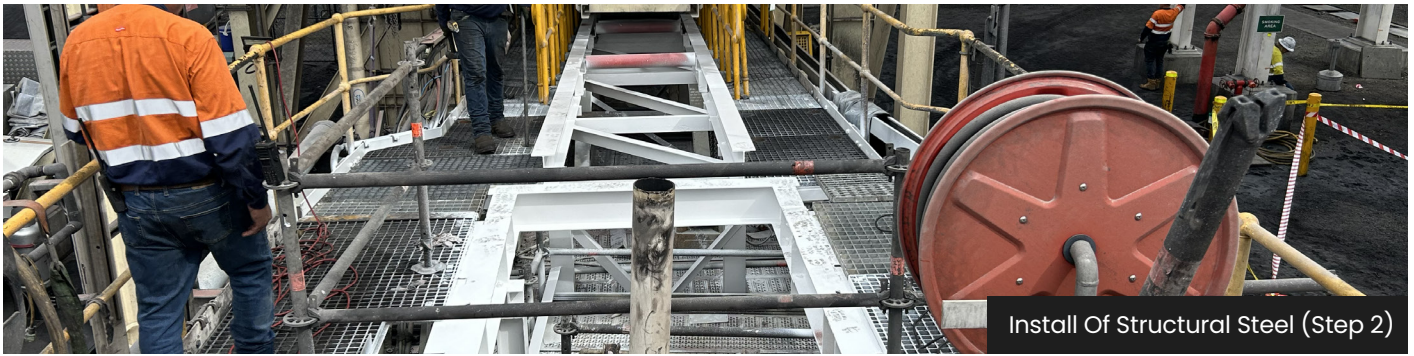
Install Of Structural Steel (Step 2)

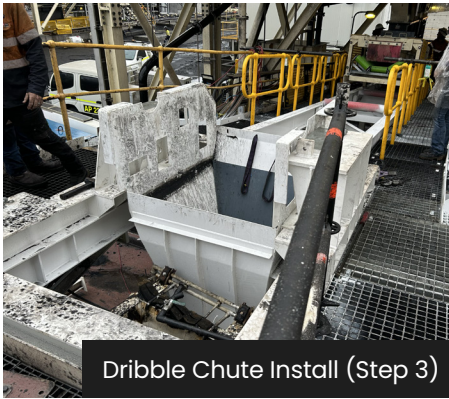
Dribble Chute Install (Step 3)

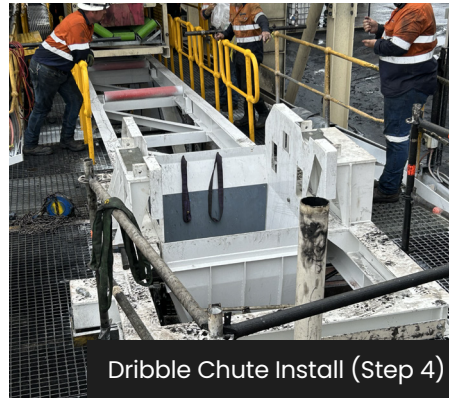
Dribble Chute Install (Step 4)

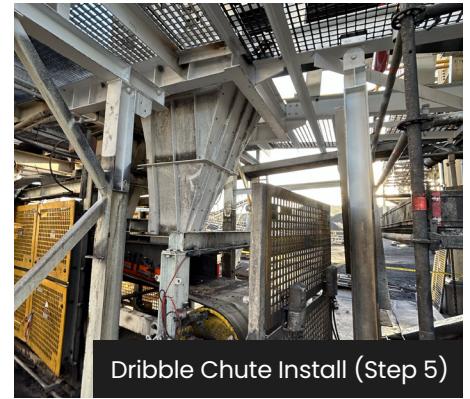
Dribble Chute Install (Step 5)

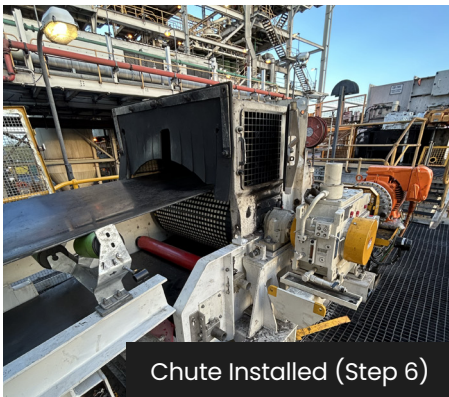
Chute Installed (Step 6)

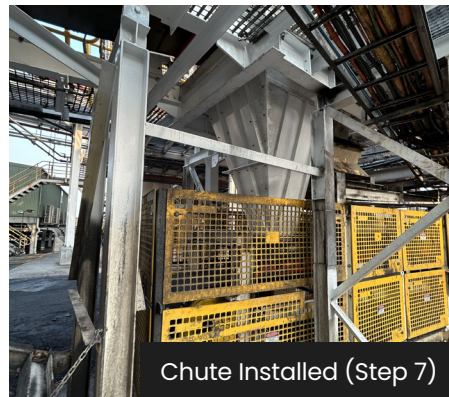
Chute Installed (Step 7)
