# Case Study

## Sealed Road Inspection & Remediation Planning

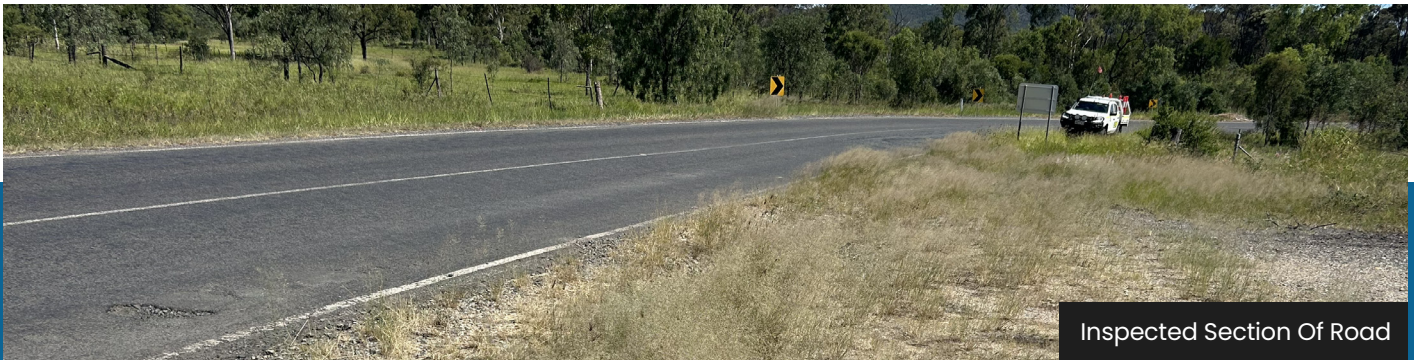
| <b>Fault Number:</b> AR18.1 | <b>Area:</b> Culvert 8400 | <b>Risk Rating:</b> High | 17 |

| <b>Description of Fault:</b> | Culvert holding water and showing signs of corrosion. | |
| <b>Failure Mode:</b> | Failure of CMP. | |
| <b>Potential Incident:</b> | Culvert failure. | |
| | Likely | Will frequently occur. |

| <b>Recommended Action:</b> | Clean inlet and outlet side to improve water flow.<br>Inspect culvert once water is removed. | |
| <b>Action Time Frame:</b> | Prompt Action Required. | |
